# THE FIERO RECALLS

Number 84-C-08 Date 02/85

Subject: MISPOSITIONED CLAMP ON HEATER INLET HOSE

Vehicles Affected: 1984 FIERO MODELS

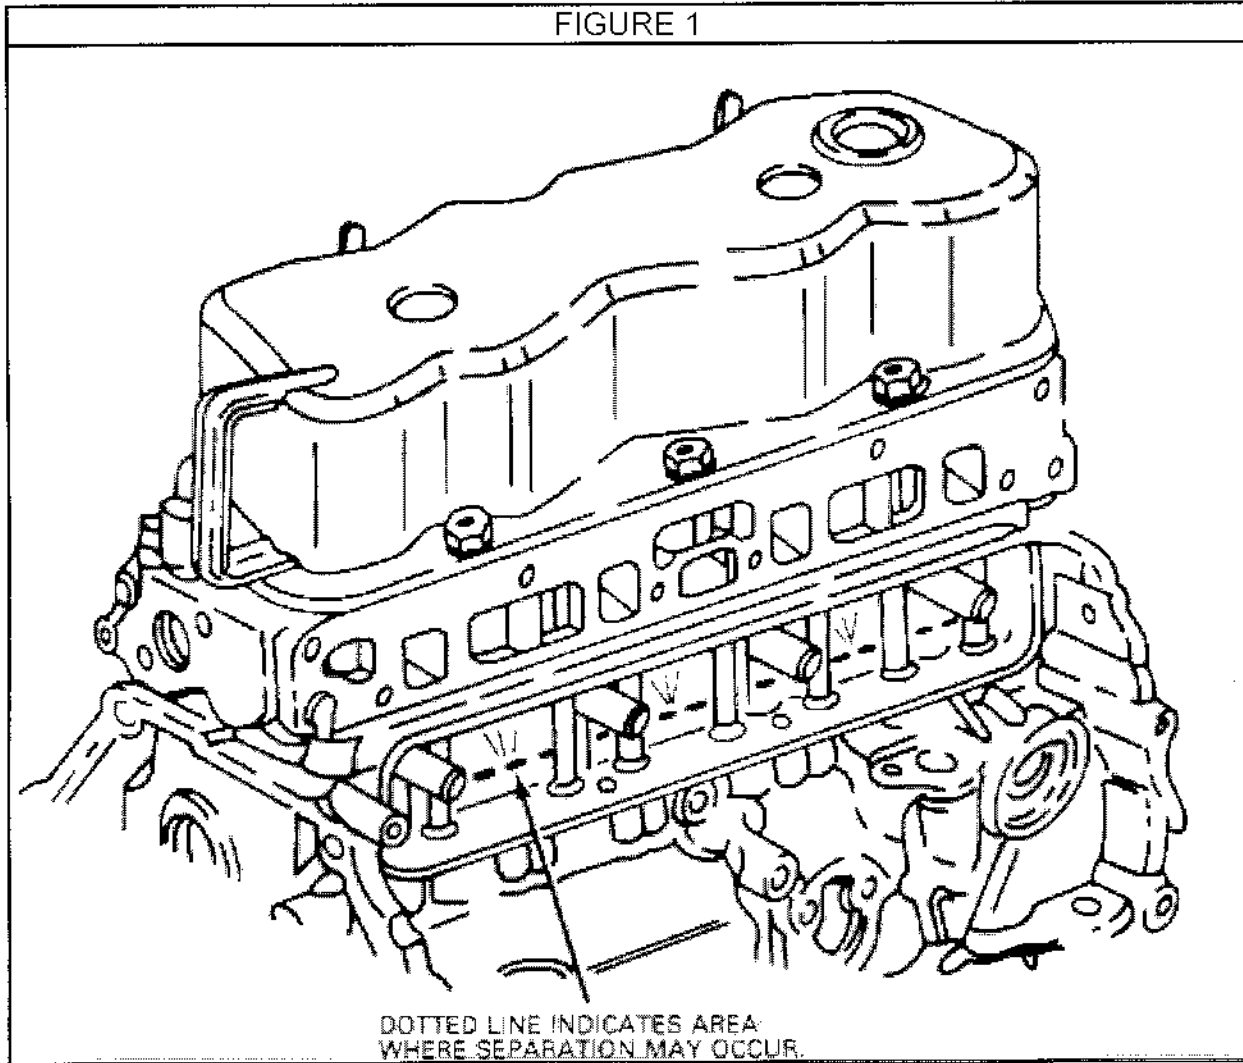
FIGURE 1

General Motors has determined that certain 1984 Pontiac Fiero models were assembled with a mispositioned upper retaining clamp on the heater inlet hose. This could allow the hose to loosen and separate from the heater inlet pipe. A separated hose could cause a loss of engine coolant which could result in premature engine failure.

3. Loosen upper clamp on heater inlet hose.
4. Reposition hose beyond second rib on heater inlet pipe (see Figure 1).
5. Position clamp between the two inlet pipe ribs and retighten to 2 N-m or 16 in.lbs.
6. Reinstall heat shield.
7. See PART II (page 3) for installation of campaign identification label.

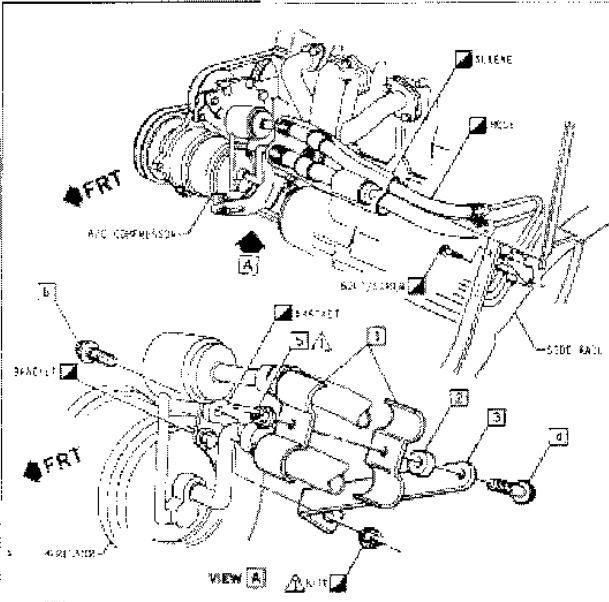
General Motors has determined that some 1986 Pontiac Fiero model vehicles equipped with 2.5L engines and air conditioning (A/C) may experience fatigue cracking of the A/C hose assembly near the compressor.

3. Remove (2) existing bolt/screws securing coupled hose assembly to side rail (refer to illustration).
4. Remove and save existing staple from existing sleeve.
5. Slide sleeve away from compressor to allow attachment of clamp to hose assembly.
6. Remove existing nut and bolt/screw, securing existing brackets to compressor.
7. Loosely attach clamps, bracket and spacer as shown in illustration.

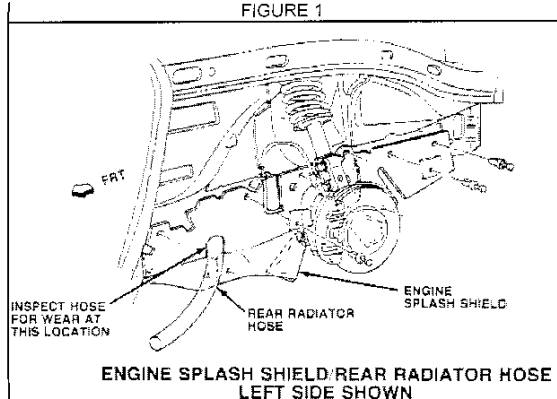
FIGURE 1

General Motors has determined certain 1985-86 Fiero model vehicles equipped with a V6 engine could exhibit an interference condition between the engine splash shields and the engine cooling system hoses. Over time, this condition could result in wear of the coolant hose(s), possibly causing a coolant leak.

1. Raise vehicle on hoist and inspect right and left-hand radiator hoses for wear from contact with engine splash shield (reference Figure 1). If the core of either radiator hose is exposed, replace hose per appropriate service manual instructions.

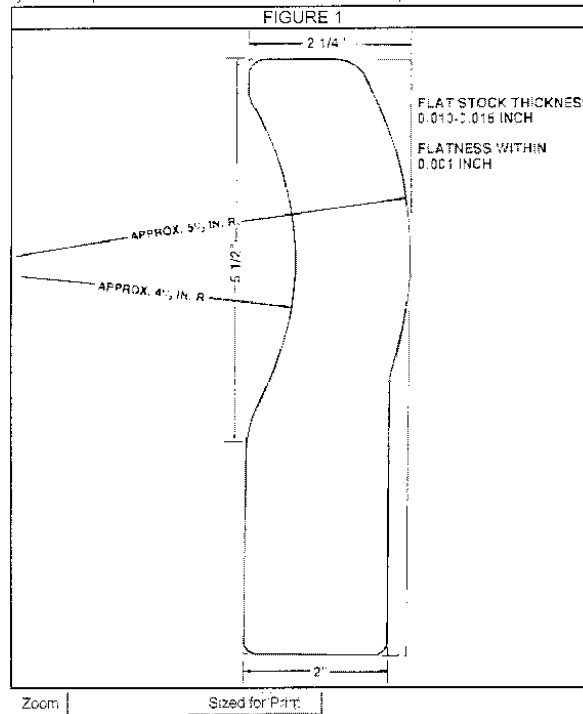
The 1982-88 Firebird, 1984-87 Fiero, and 1984-88 6000 STE vehicles with the rear disc brake calipers are designed to automatically adjust. Some vehicles may experience increased rotor to lining clearance if the rear calipers do not adjust fully. The following is a procedure that can provide manual adjustment and can be repeated, if necessary.

1. Raise vehicle.
2. Remove rear wheels.
3. Reinstall two lug nuts on each axle to hold rotors in place..
4. Fully apply and release the park brake three (3) times.
5. Verify that the park brake levers are in the full release position as described in the service manual.

6. Pry caliper outboard to produce a gap between outboard pad and rotor. Insert a 0.010 to 0.015 inch shim between the outer brake pad and the rotor. Suggested shim shape is shown in Figure 1.
7. Apply the park brake, trapping the inch shim between the rotor and the outer brake pad.
