Tech Articles

Tank U

By: Ray Dyreson

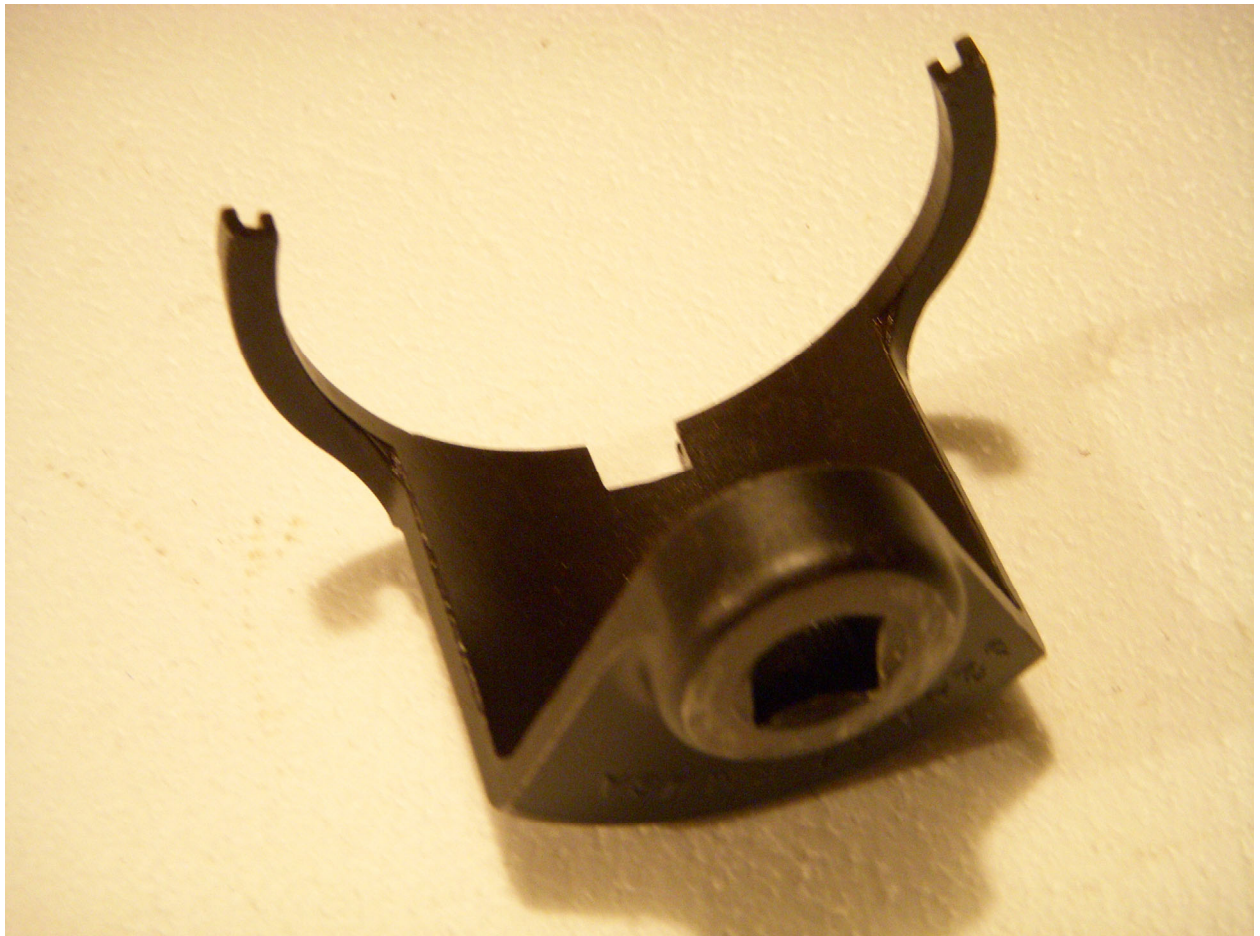
When removing the sender from the tank you can rotate the cam lock ring with a hammer and punch or dull screwdriver. However, the proper Kent Moore tool, part number J-28147, makes the job easier with less potential for damaging the ring and tank (Image 3). Always install a new seal, AC Delco #G10. Replace the ring if damaged, AC Delco #TR11. The locking ring and seal are also sold as a set by Dorman as part #579-001.
