# THE FIERO RECALLS

Number 84-C-08 Date 02/85

Subject: MISPOSITIONED CLAMP ON HEATER INLET HOSE

Vehicles Affected: 1984 FIERO MODELS

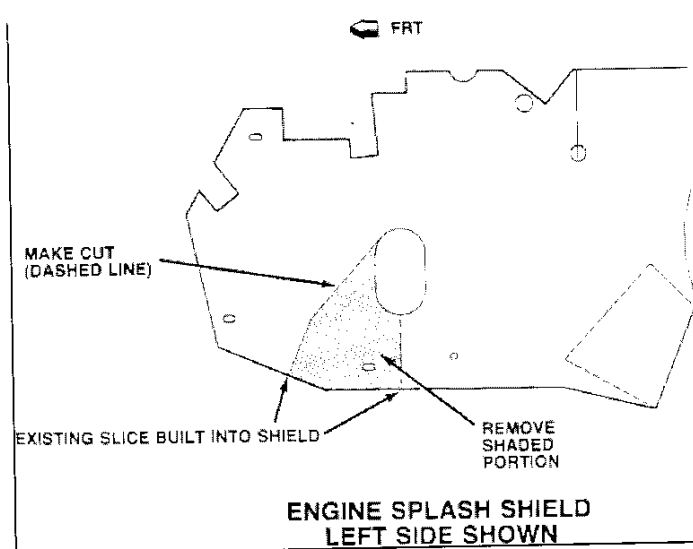
1. Raise vehicle on hoist and inspect right and left-hand radiator hoses for wear from contact with engine splash shield (reference Figure 1). If the core of either radiator hose is exposed, replace hose per appropriate service manual instructions.

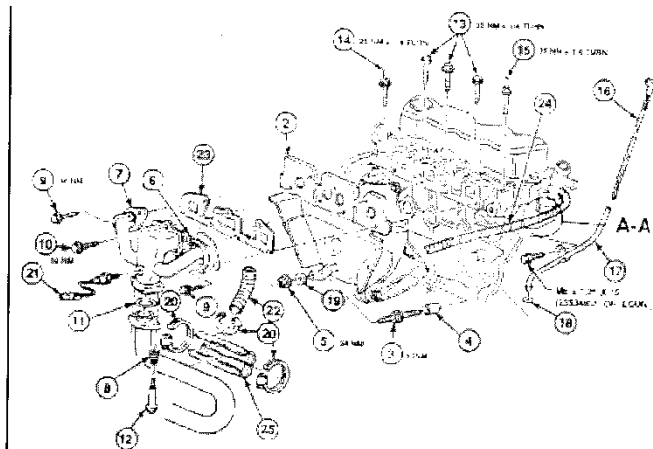
ILLUSTRATION A - 1984-86 MODELS

If combustible materials come in contact with the exhaust manifold, an engine compartment fire can result. Engine compartment fires can spread to the passenger compartment and cause injury to occupants.
