## CODE 45

### OXYGEN SENSOR CIRCUIT (RICH EXHAUST INDICATED) 2.5L "P" SERIES (TBI)

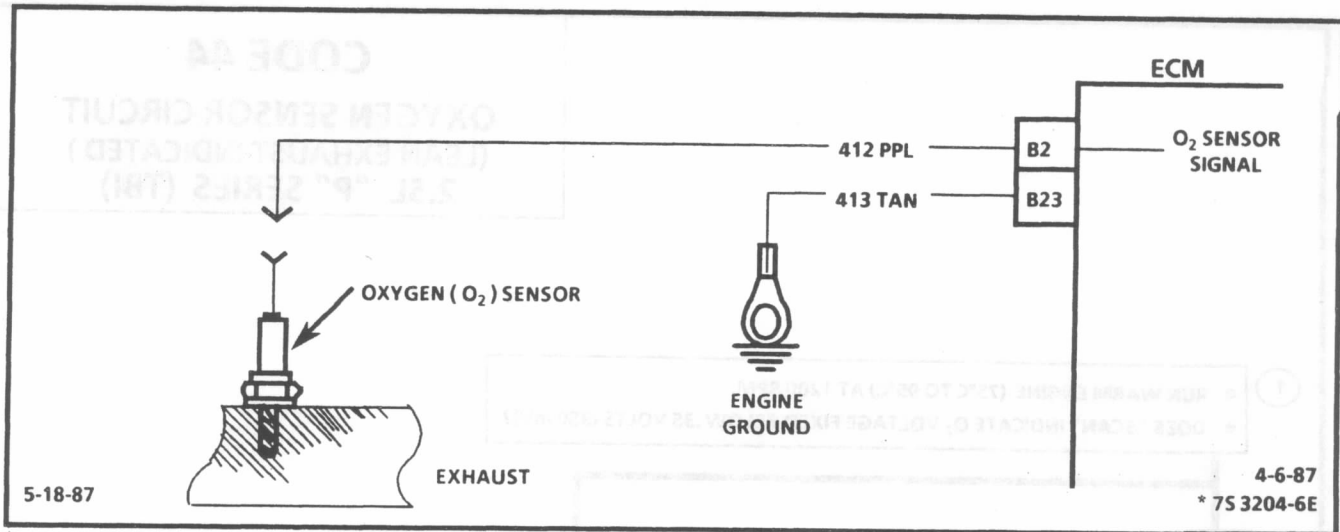
The ECM supplies a voltage of about .45 volt between terminals "B2" and "B23". (If measured with a 10 megohm digital voltmeter, this may read as low as .32 volts.) The O<sub>2</sub> sensor varies the voltage within a range of about 1 volt, if the exhaust is rich, down through about .10 volt, if exhaust is lean.

The sensor is like an open circuit and produces no voltage, when it is below about 360°C (600°F). An open sensor circuit, or cold sensor, causes "Open Loop" operation.

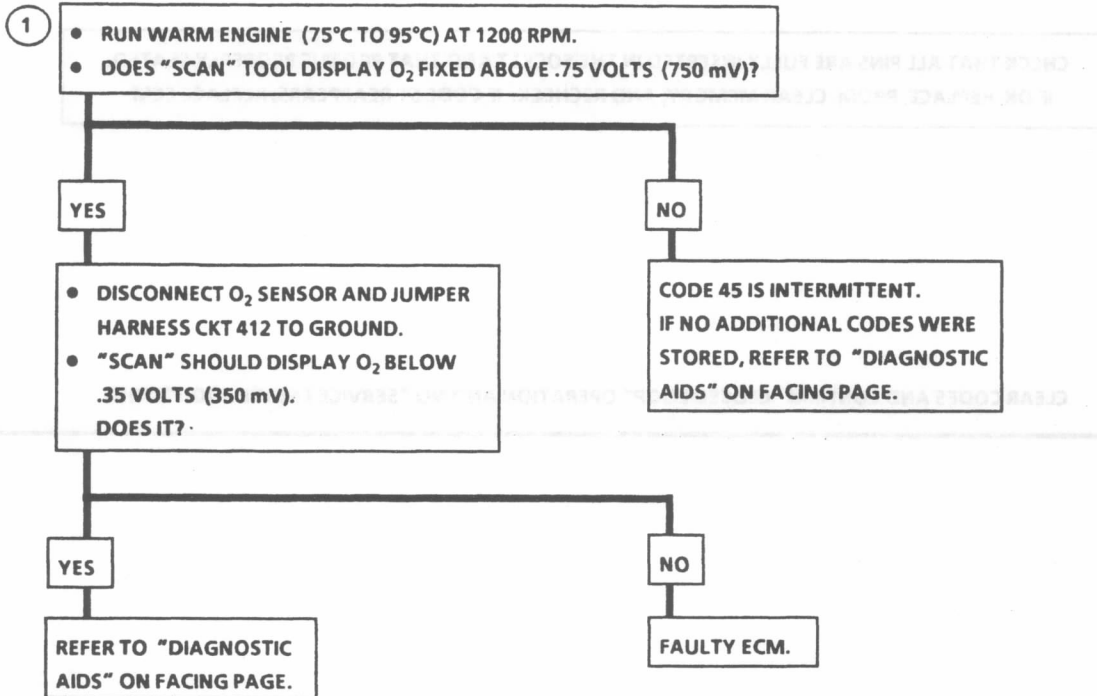
# CODE 45

CLEAR CODES AND CONFIRM "CLOSED LOOP" OPERATION AND NO "SERVICE ENGINE SOON" LIGHT.

**Test Description:** Numbers below refer to circled numbers on the diagnostic chart.

1. Code 45 is set, when the O<sub>2</sub> sensor signal voltage on CKT 412:
  - Remains above .7 volt for 30 seconds or more; and in "Closed Loop".
  - Engine time after start is 1 minute or more.
  - Throttle angle between 3% and 45%.
