V6 Exhaust Manifold Repair & Porting...

by Ron Dittmer - Revised February 2002

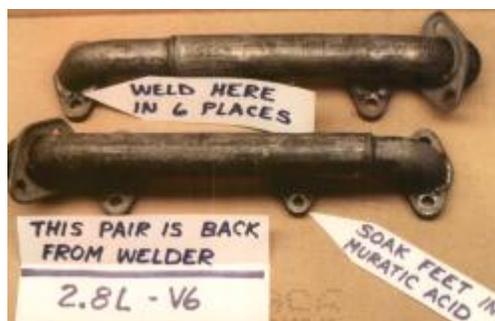
The Fiero V6 engine is prone to developing exhaust manifold cracks and leaky manifold gaskets. The function of the manifolds are to tie the engine to the exhaust system. There is one on each side of the engine, just below the bank of three spark plugs. Each has three side tubes (or "Ports" as they are named) that mate to the engine head, and one main exit tube, which bolts to the exhaust crossover pipe. Each engine cylinder uses one dedicated port. Pontiac's sloppy production methods of the exhaust manifolds have resulted in exhaust flow restrictive areas, which when removed can increase the horsepower of your V6 by around eight horsepower.

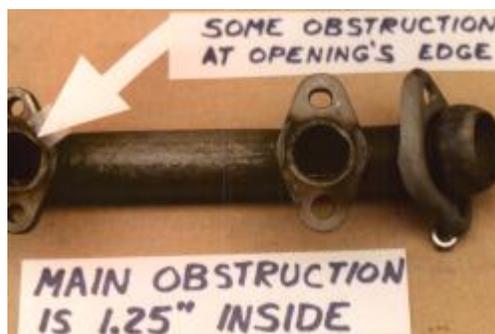
After removing both manifolds, I inspected them and their gaskets, finding numerous leaks. Four of the six ports had some sort of leak. Black soot made it easy to diagnose. One port was cracked where the stainless pipe mates to the iron foot. Three ports leaked past the gasket, the result of loose bolts. There was also a crack in one manifold near the crossover pipe fitting. All the leaks surprised me because there was no indication of leakage, other than the engine ticking noise. Engine operation seemed fine. I could not see any soot without first removing the manifolds, so inspecting them prior to removal revealed nothing.

I decided to repair the old manifolds, rather than buying new ones. After all, I planned to grind out the obstructive material, then reinforce them by welding ring beads where the stainless pipe meets with the iron feet. I had the cracks re-welded as well. A welder did all the work on both for \$30.00 total, much less than \$170.00 for one new manifold. I gave him the manifolds bolted to hardwood to minimize foot planarity problems. Also, I soaked the iron feet in muriatic acid to strip off the rust, insuring a good weld. When I got them back from the welder, I touched them up with a belt sander to perfect their flatness. My welder was an industrial machine shop. I asked them to use their standard stainless welding rods. They knew what I was talking about. When I got them back from the shop, I had to dress up the inside again, a little. Taking them to the shop before I did any grinding would have been much better.

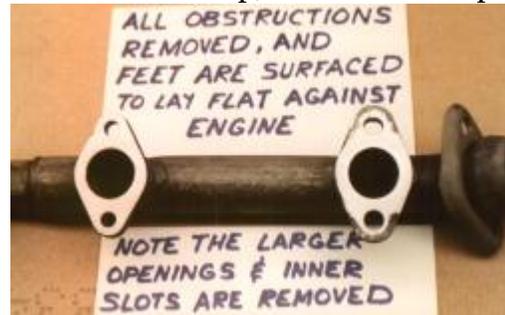
Be concerned of having an auto repair shop do all this for you. I've heard of \$500.00 for replacing one manifold. I don't believe they would be as careful as you either. If you snap a manifold bolt, it is a REAL HASSLE to drill out the stud, but it IS possible to do without removing the engine or other major

disassembly. A few mechanics have been known to reassemble everything with the snapped bolt still in place, leaving the manifold susceptible to a gasket failure. If you decide to have someone do this job for you, make sure to inspect all twelve bolts, both before and after the work is done. If you have a missing bolt's hex head, you have a broken or missing bolt. Let your mechanic know that you are aware, and concerned of it.
