Paul's Product Review

New V6 EGR Tubes

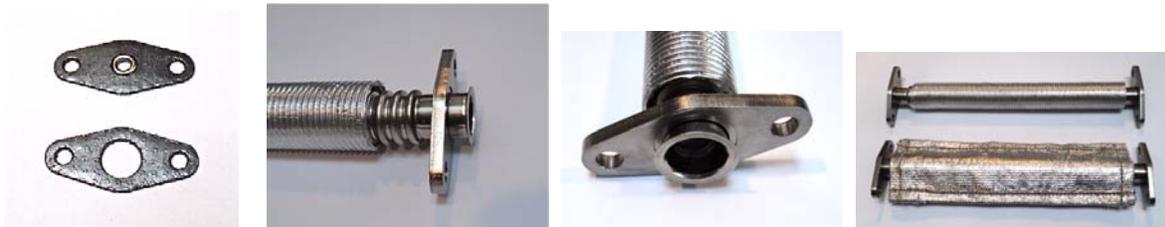
The '88 EGR tube is shown on the top and the '85-'87 at the bottom in Image 1. The tube section is made of one continuous piece of 304 Stainless steel tubing (the flanges are also 304 stainless steel). There are no welds at the flange ends, since this is where the GM OEM tubes typically break (Image 2). The heat shielding is very close to the OE tubes for the specific year(s). These EGR tubes also include two new EGR gaskets (Image 3). The EGR gasket that goes on the intake manifold has a smaller hole in it. GM upgraded to this smaller hole in the later EGR tubes to undoubtedly control a runaway high idle condition if the EGR tube broke. Rodney further improves these pieces by adding a stainless steel insert to eliminate any erosion of the graphite gasket. These EGR tubes are easily hand bent to the same contour as the OEM EGR tube.

One of the most frustrating Fiero V6 failures is the EGR tube that attaches under the intake plenum and connects to the base of the EGR valve. Over time, as the engine vibrates, the weld at the flange joints fail and a vacuum leak becomes apparent as a faster idle. Rodney Dickman now manufactures OE replica EGR tubes for both the '85-'87 V6 and also the '88 V6 (Image 1).
